Listed Buildings Homington

Pheasant Cottage

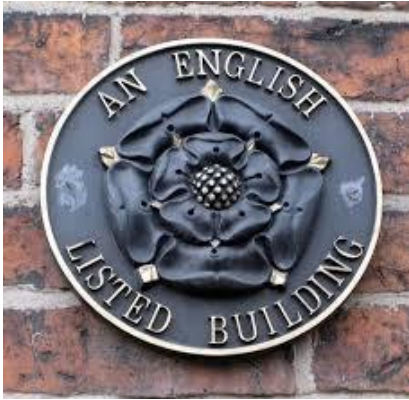
HOMINGTON VILLAGE (north side) Pheasant Cottage II Detached cottage. Late C17 with some rebuilding c1800. Chalk and flint chequers, thatched roof, brick stacks. Single-storey and attic, 2 windows.

Planked door to right of centre in C20 weatherboarded porch, to right is 2-light casement and left is 3-light casement and fixed window. Two eyebrow dormers with 2-light casements. Left return has metal casement to ground and attic floors. Right return has small casement to ground and attic floors.

Rear has French windows and C20 casement to ground floor. Attached to left is C20 lean-to extension. Interior said to have timber-framed partition to first floor. (Unpublished records of RCHM (England), Salisbury).
