Listed Buildings

Homington

Westende

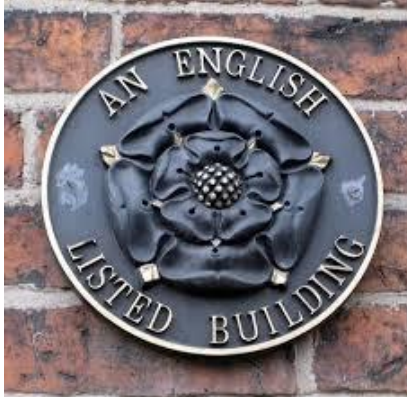
HOMINGTON VILLAGE (south side) Westende II Detached farmhouse, now house. C16 2-bay house, rebuilt late C17, late C18 east additions, mid-C19 extension to east, C20 renovations. Rendered C17 walls, Flemish bond to C18 and C19 additions, tiled roof with brick and limestone stacks. L-plan. 2-storey, 4-window front. C20 central door in C18 part, has rustic porch of reused timbers, to left is C20 casement.

First floor has two C20 casements to left, C17 part to right has two single recessed chamfered lights. Right return has central blocked door with C20 casements either side, catslide roof has two hipped dormers with casements. Rear has C20 glazed conservatory to ground floor, first floor has two C20 casements. Main range to left has C20 casement on return, and C20 casements to ground and first floors of gable. Interior not accessible but said to have late C17 open fireplace with timber Tudor arch on chamfered brick jambs, late C18 addition has chamfered ceiling beams. RCHM recorded C16 timber-framing, including a jettied first floor on the west side, now encased by C17 rebuild.
